## PRESS STATEMENT

### **Fatal Accident at Package V4 by Sunway Construction**

## Details of Accident

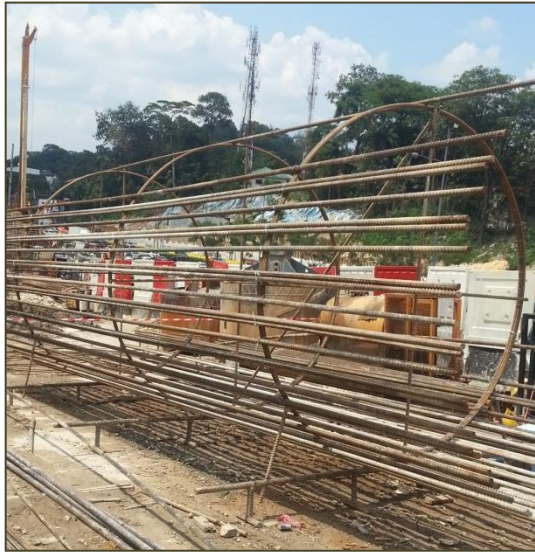
A side view of the rebar cage that was being fabricated.

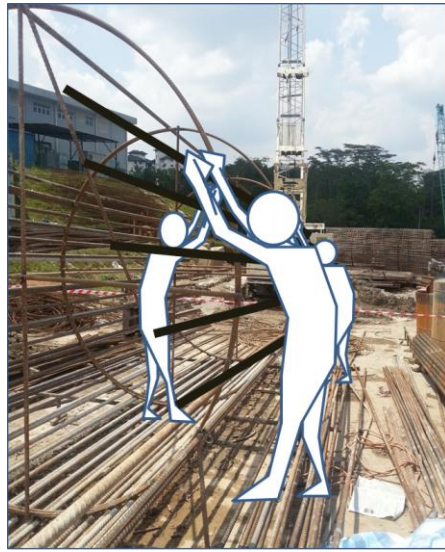
1. One MRT worker was tying the rebar to the cage from the inside.
2. Another two workers were holding the rebar from the outside.

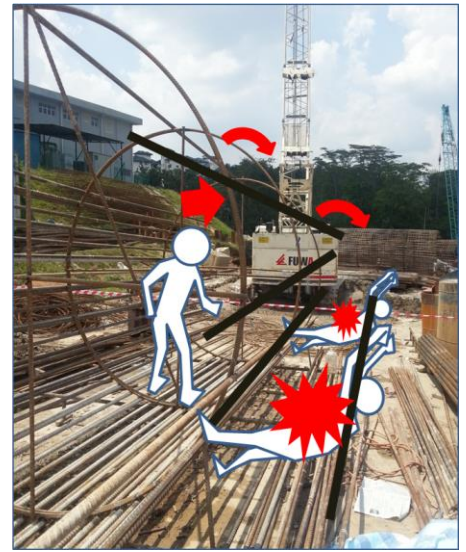
1. The tie wire broke and the rebar slipped from both workers' hands.
2. The falling rebar in turn hit other rebars, which fell onto the two workers.

- Lack the work trade skills related to the task
- Lack general safety awareness

The root cause is the absence of basic training in work skills and safety practices.
